EURSTRCN

EMBRACING SUNLIGHT

Lasting generations of technology

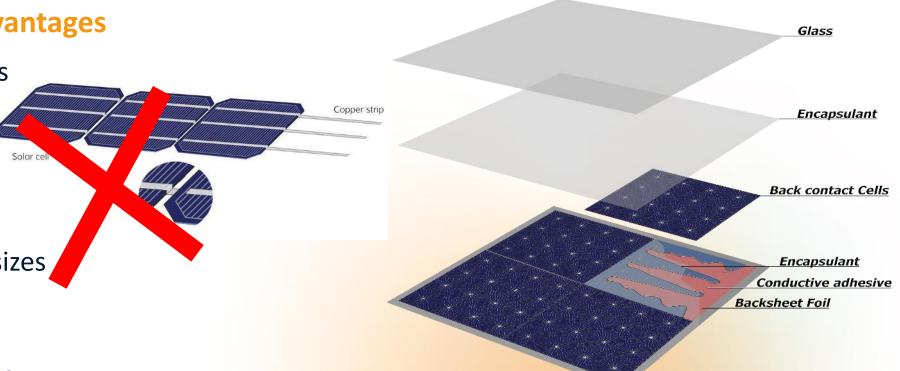
Build-in technology advantages

Reduction of serial losses

Lower NOCT

Better producability

Less cell breakage

Denser cell spacing

Allows for different cell sizes

- Less hotspots
- Flexible design
- Better optical appearance

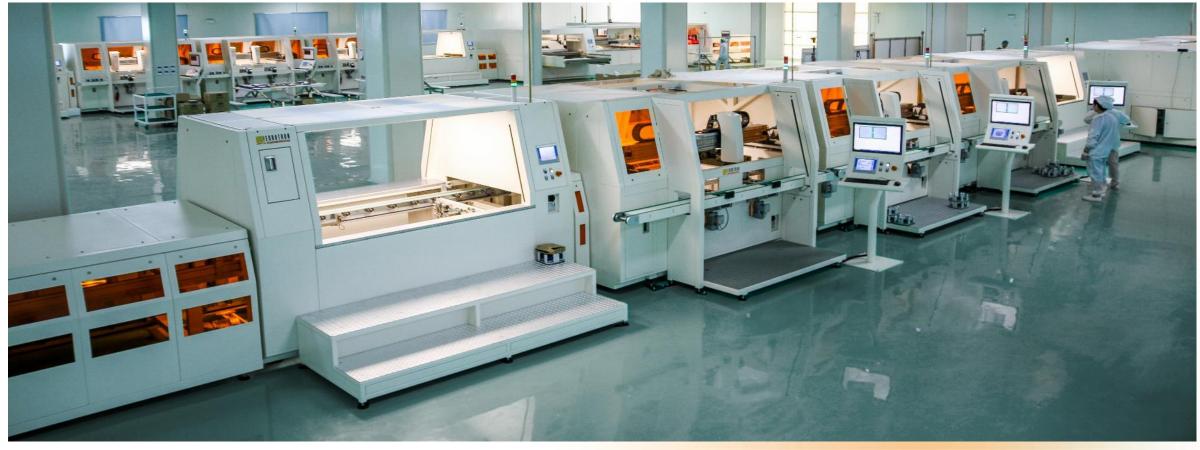
Process steps

- 1 Upwards elevator
- 2 Back sheet lay-up
- 3 Interconnection
- 4 Application of encapsulant
- Quality inspection
- 6 Cell positioning

- 7 Quality inspection
- 8 Encapsulant unwinding and application
- 9 Glass de-stacking and lay-up

- 10 Pre-tagging
- 11 Flipping
- 12 Downwards elevator

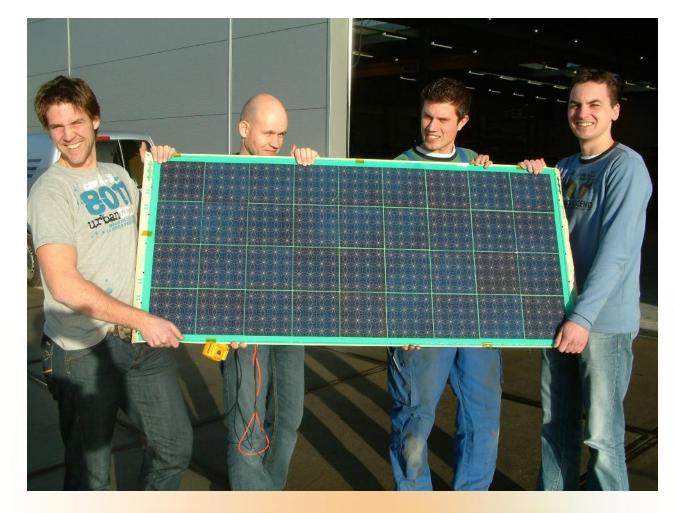
Eurotron's first foil-based back contact module

Build in Nov 2007
→ 15 years ago

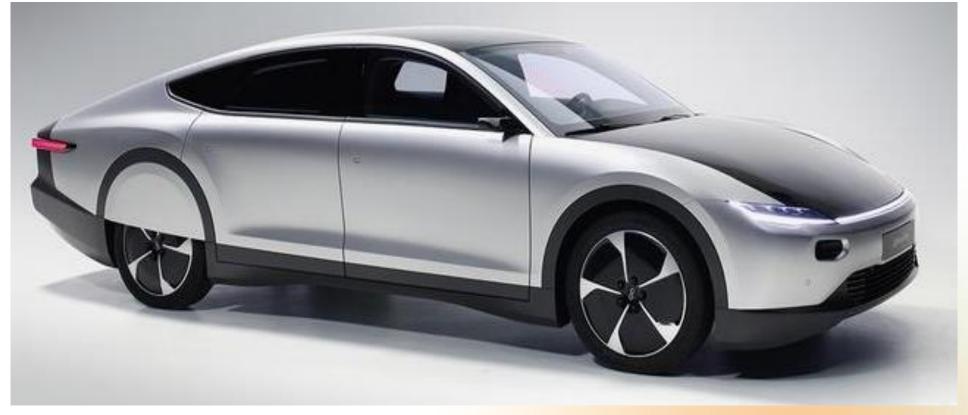
Lasting generations of modules
